## ***Moreno Valley Wetland Action Plan***

***Prepared by  
Joanne Hilton, P.G.  
in cooperation with  
the Cimarron Watershed Alliance  
and the  
New Mexico Environment Department (NMED)***

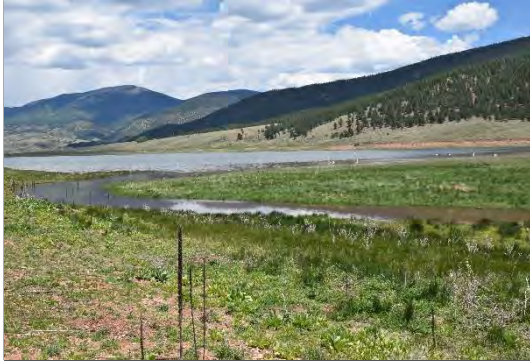
**Lacustrine fringe wetlands** are adjacent to lakes where the water elevation of the lake maintains the water table in the wetland. Both precipitation and groundwater discharge provide additional sources of water. Surface water flow is bidirectional and is usually controlled by water level fluctuations in the adjoining lake. Lacustrine wetlands lose water by water flow that returns to the lake after flooding, by the saturation of surface water flow, and by evapotranspiration.

--Lacustrine fringe wetland shown at right where Cieneguilla Creek enters Eagle Nest Lake

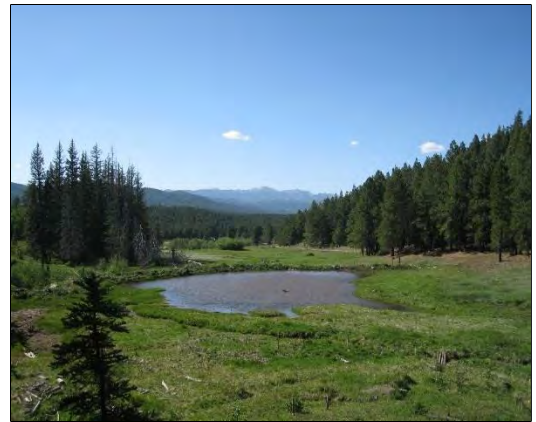
**Depressional wetlands** occur in topographic depressions with a closed elevation contour that allows surface water to accumulate. Precipitation, groundwater discharge, and interflow from adjacent uplands are the dominant sources of water for these wetlands. Since water normally flows from the surrounding uplands toward the center of the depression, the depressional wetlands may consist of any combination of inlets and outlets, or may lack them completely.

--Depressional wetland (pond)

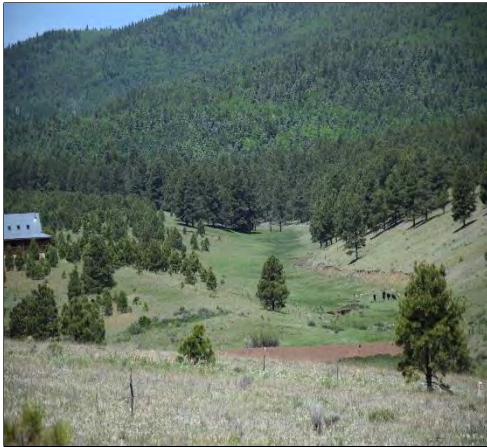
*--Slope wetlands with headcut*

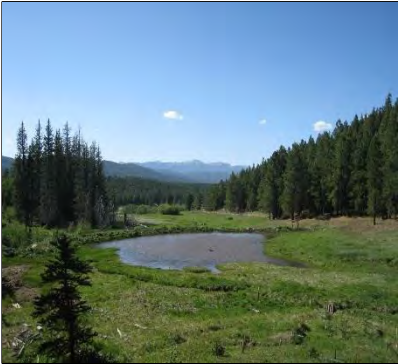
**Palustrine fringe wetlands** are adjacent to ponds where the water elevation of the pond maintains the water table in the wetland.

*--Palustrine fringe on perimeter of pond*

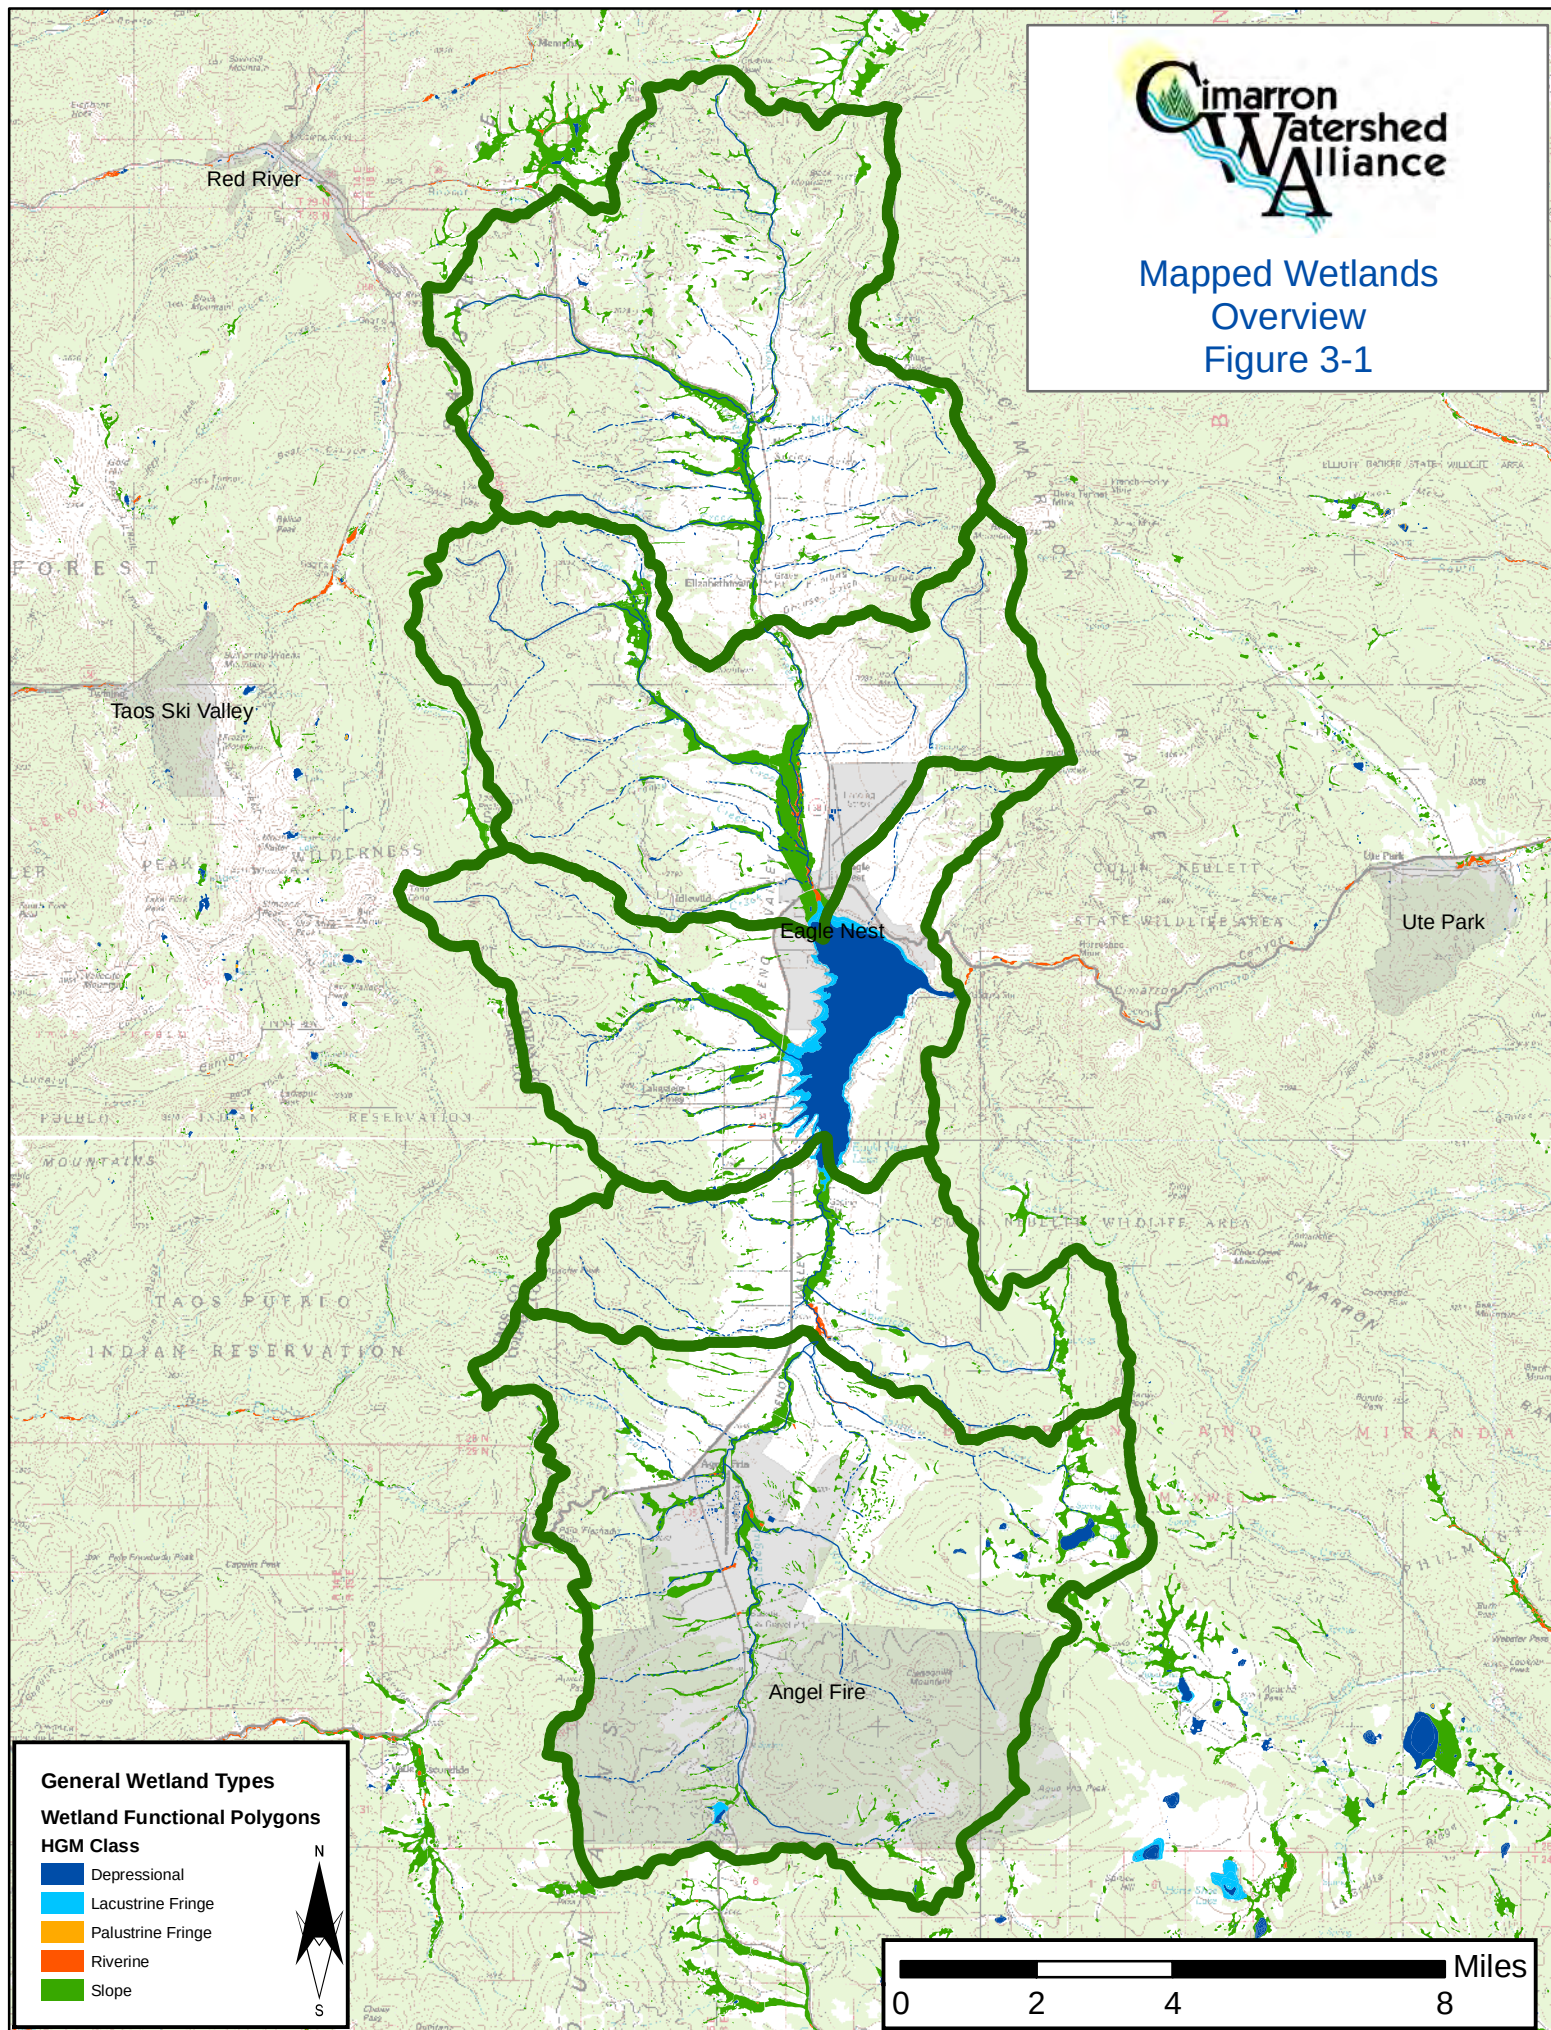
## Mapped Wetlands Overview Figure 3-1

An overview of the mapped wetlands using the HGM classification system is shown in Figure 3-1. More detailed maps of the 5 subwatersheds in the Northern (Moreno Headwaters and Moreno Outlet Subwatersheds), Central (Eagle Nest Lake Subwatershed), and Southern areas (Cieneguilla Outlet and Cieneguilla Headwaters Subwatersheds) of Moreno Valley are shown in Figures 3-2 through 3-6.

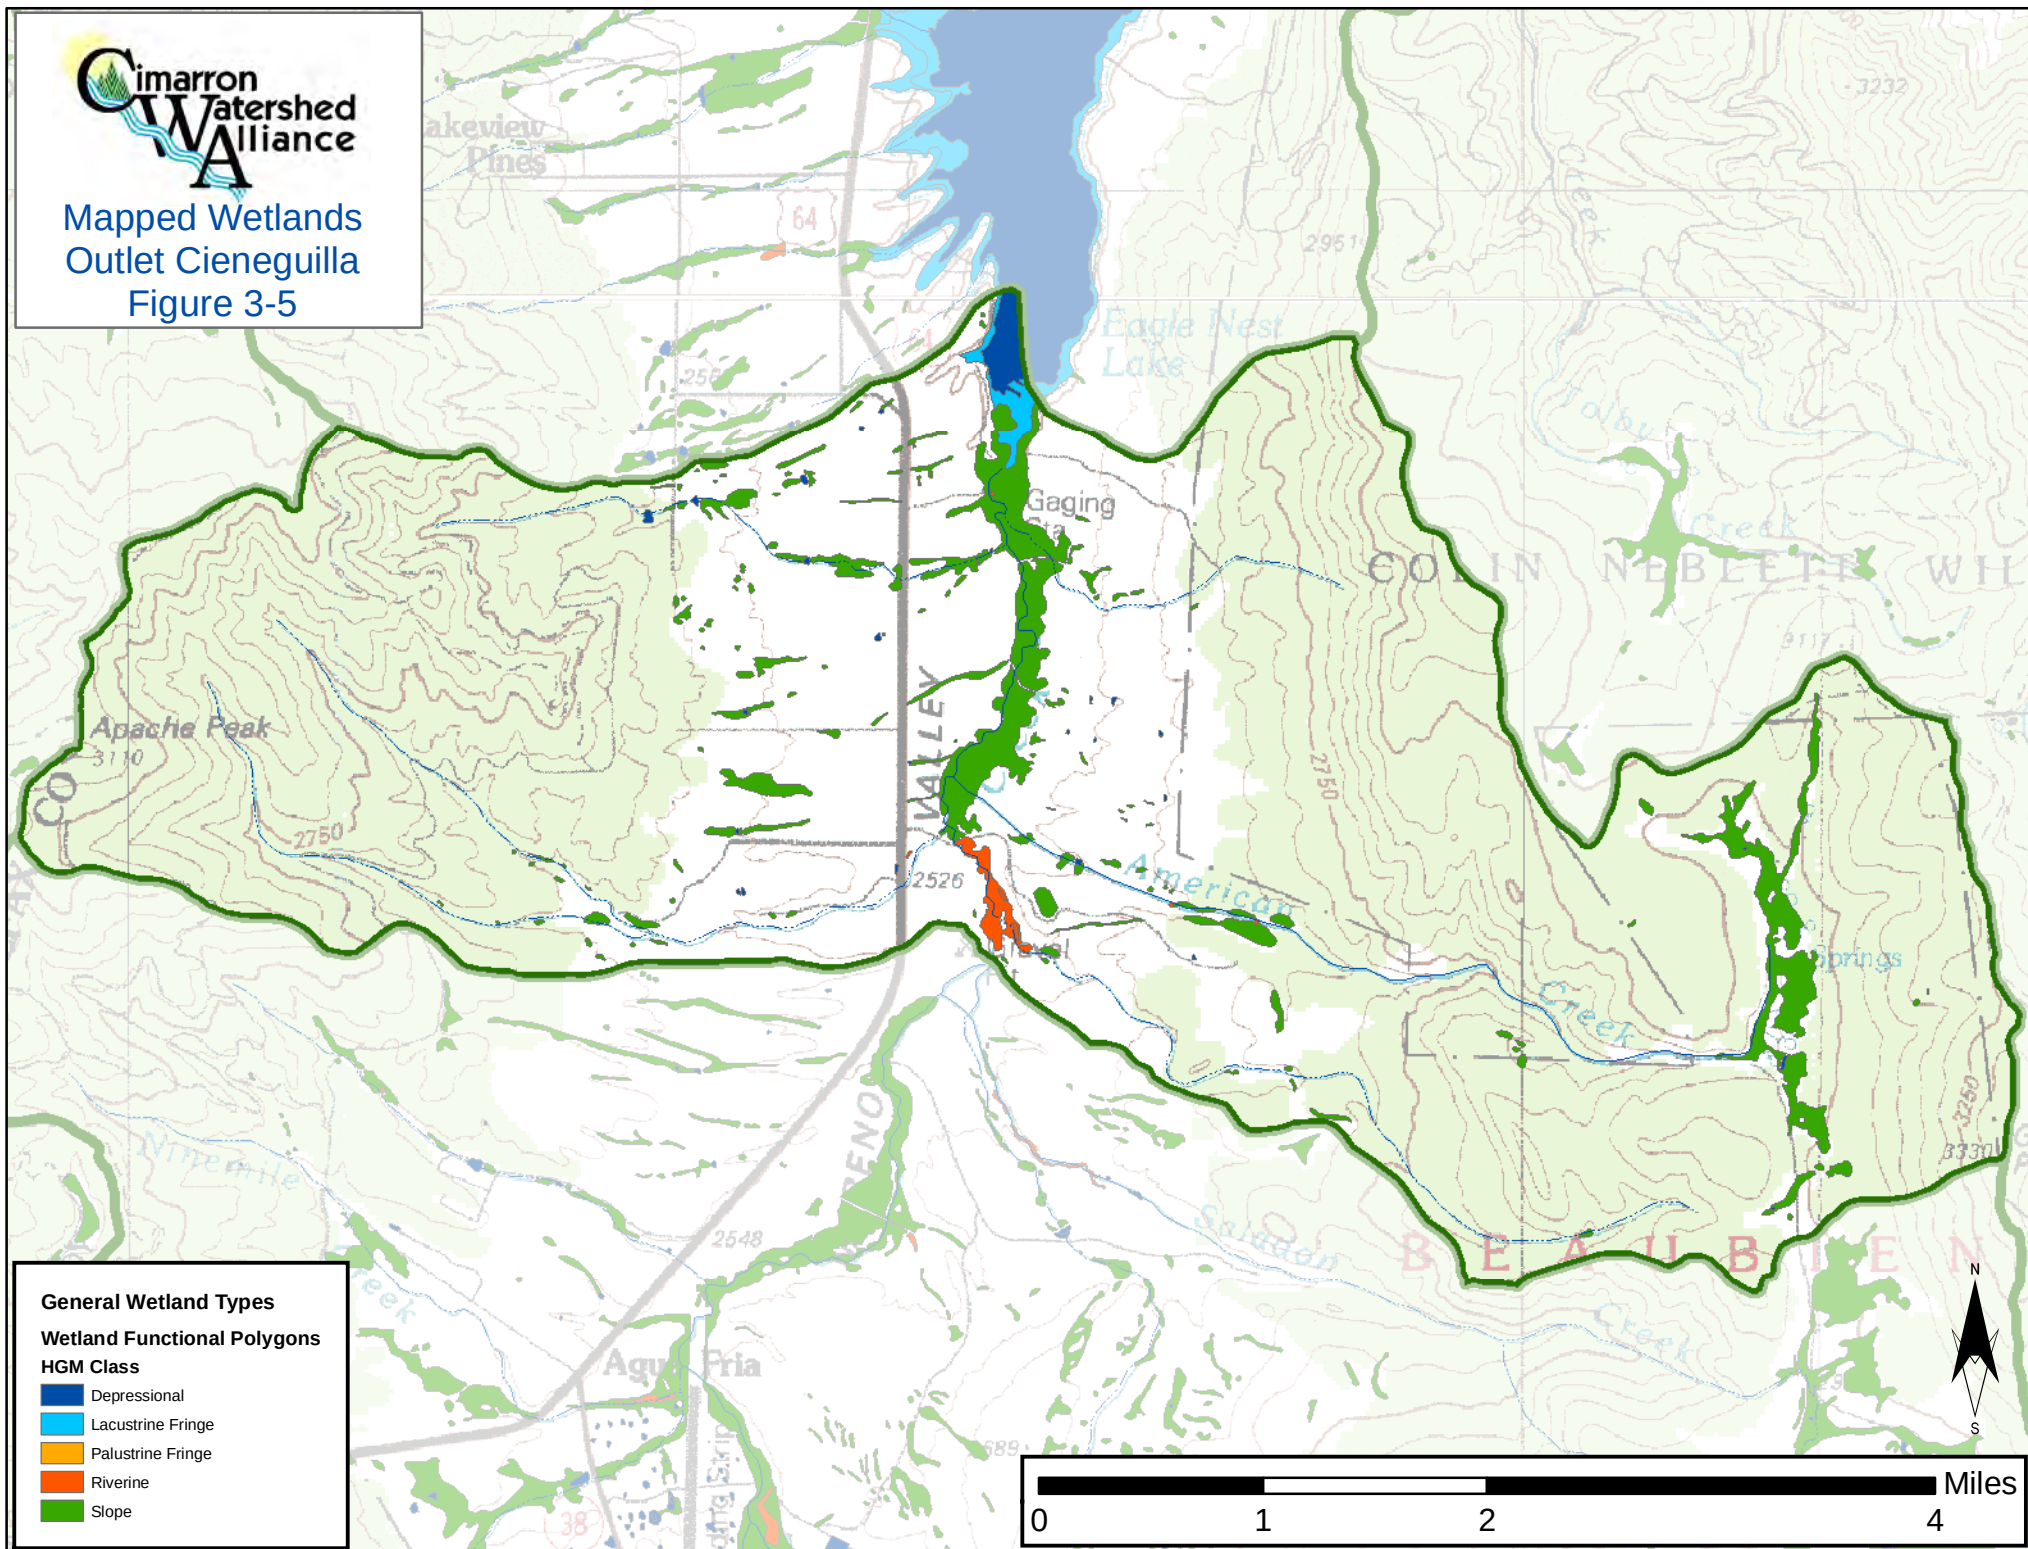
Mapped Wetlands  
Outlet Cieneguilla  
Figure 3-5

**General Wetland Types**  
**Wetland Functional Polygons**  
**HGM Class**

- Depressional
- Lacustrine Fringe
- Palustrine Fringe
- Riverine
- Slope

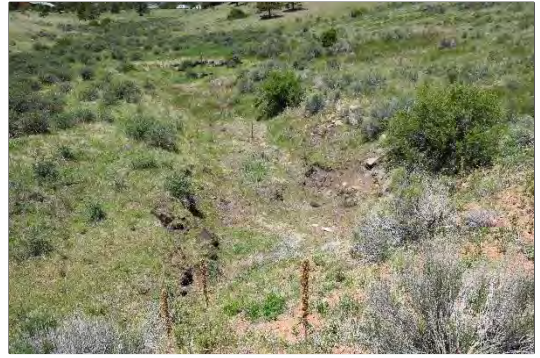
--Presence of shrubby cinquefoil is an indicator of slope wetlands drying below road and culvert

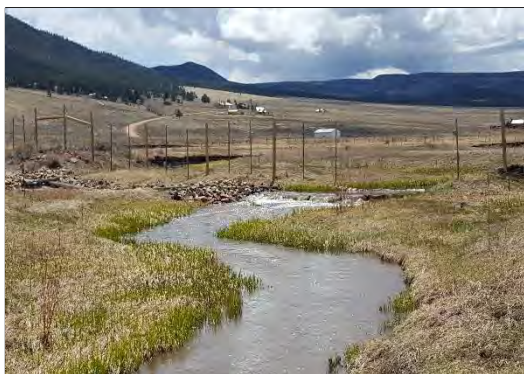
-- Elk enclosure near Eagle Nest Lake

Grazing exclosures may be used to prevent access to important areas for protection. Elk exclosures have been installed on the south side of Eagle Nest Lake. Livestock best management practices, such as rotation and alternate water sources, can be used by ranches in the area to minimize impacts to wetlands. Education and financial assistance may help local ranches to implement grazing best management practices.

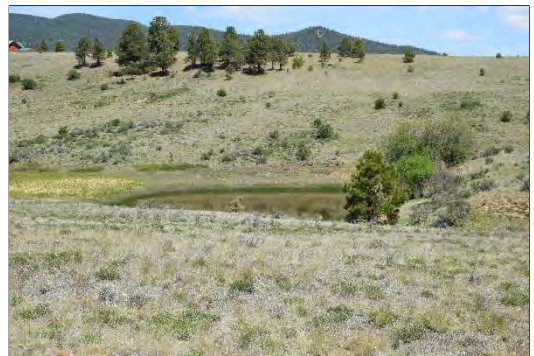
**Diversion Ditches and Earthen Stock Tanks.** Diversion ditches that move water away from the head of slope wetlands to water other areas can cause drying of the wetlands downgradient. Earthen stock tanks excavated into slope wetlands capture and impound the water. Although some of the water infiltrates the earthen dam, the water downstream is reduced, resulting in drying of the wetland. In some cases, there may be historic diversion ditches and stock tanks that are no longer needed and can be de-commissioned in order to restore slope wetlands.

--Stock pond built on slope wetlands

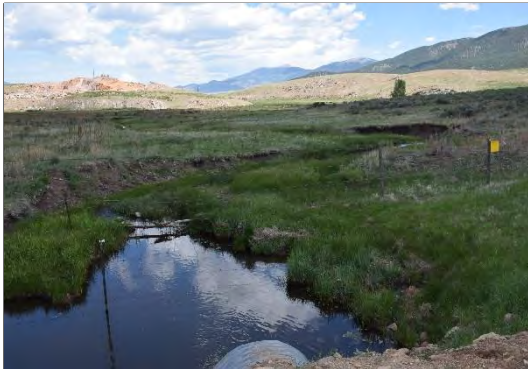
Poorly designed roads or drainage, poorly managed grazing, diversion ditches, and/or stock tanks, wildfires or other upland land disturbances, or any combination of these impairments can lead to headcuts, channelized flow (disconnection from the floodplain), and sediment loading.

--Riverine wetlands on incised Cieneguilla Creek
